# Manhole Inspection Summary

Manhole # S37U1\_021MH

Insp Date: **2/19/08 11:03 AM**

**Location** Address: **3560 3rd St**

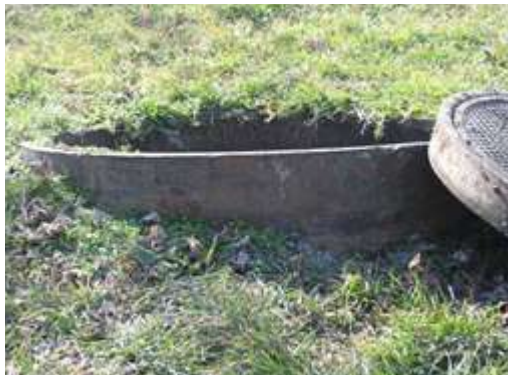
Defect 1

Above grade

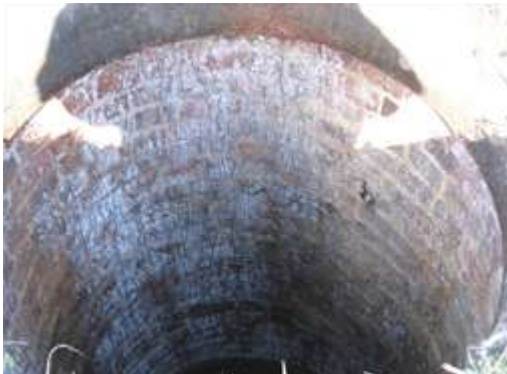
Defect 2

Infiltration: ☐ None ☐ Joint ☐ Cracks ☐ Mortar ☐ Roots ☒ **Wall**

Wall

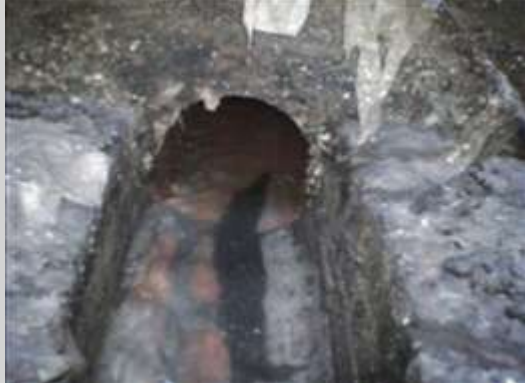
12 O'Clock Outflow

8 in. Circular Gravity Sewer  
Pipe Out @ 12 O'Clock

Pipe Height: **10.8** (in.) Rod and Bar (Angled)  
Pipe Material: **Clay** ☐ Pipe Lined  
Invert Depth: **11.17** (ft.) Flow Characteristics: **Fast**  
Deposits: ☒ None ☐ Mud ☐ Sludge ☐ Debris ☐ Grease  
Silt Depth: (in.) Deposits Extent:  
Infiltration: **None** Pipe Seal Cond: **Sound**

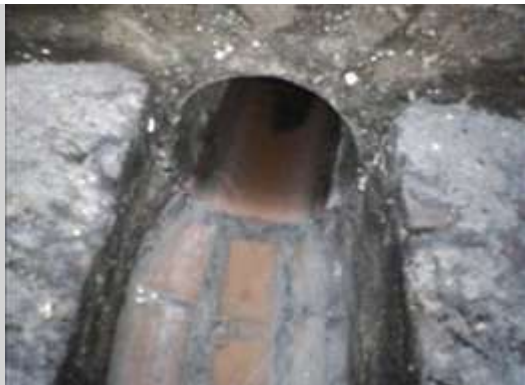
6 O'Clock Inflow

8 in. Circular Gravity Sewer  
Pipe In @ 6 O'Clock

Pipe Height: **9.6** (in.) Rod and Bar (Angled)  
Pipe Material: **Clay** ☐ Pipe Lined  
Invert Depth: **10.85** (ft.) Flow Characteristics: **Fast**  
Deposits: ☒ None ☐ Mud ☐ Sludge ☐ Debris ☐ Grease  
Silt Depth: (in.) Deposits Extent:  
Infiltration: **None** Pipe Seal Cond: **Sound**
